# The 21 February 2005, catastrophic waste avalanche at Leuwigajah dumpsite, Bandung, Indonesia

**Background:** On 21 February 2005 the Leuwigajah dumpsite, Bandung (Java, Indonesia) was affected by a large slide after heavy rainfalls. Second deadliest waste slide in history, it buried 71 houses and killed 143 people. Amongst the contemporary disastrous events of this type, only a few have been documented. We explored failure preconditions, triggering mechanisms and local context that conducted to this disaster. We carried on four field investigations on the site. A series of aerial photographs were acquired and completed by topographical measures on the ground. The morphology of the slide and its trajectory were reconstructed. To constrain the movement condition, we studied the internal structure of the source area and realized surveys among stakeholders of the dumpsite and citizen.

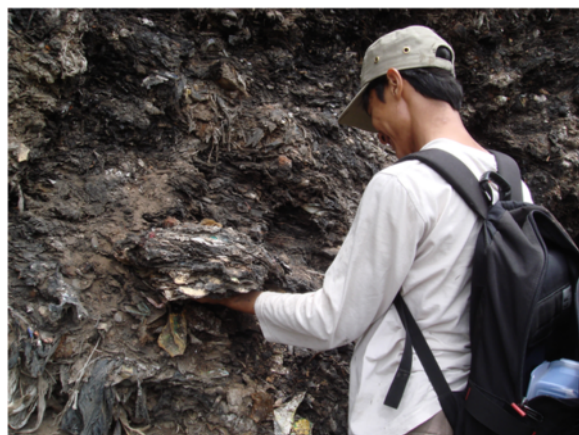
**Figure 3** Sampling of the waste deposits (photo: F. Lavigne, February 2007).

Below the surface, the layers comprise plastic bags remnants mixed with soil and a fine-grained matrix of decomposed organic garbage. Other materials found within the deposits were plastic pieces, stones, pieces of wood, metallic material etc. The main part of the deposit displays a finely foliated structure generally underlain by remainders of plastic bags. All the material shows a preferential fabric rather parallel to the previous topography. Outcrops conform to the displacement direction are showing undulating discontinuities that delimit 5 to 30 cm thick stratified layers (Figure 6).

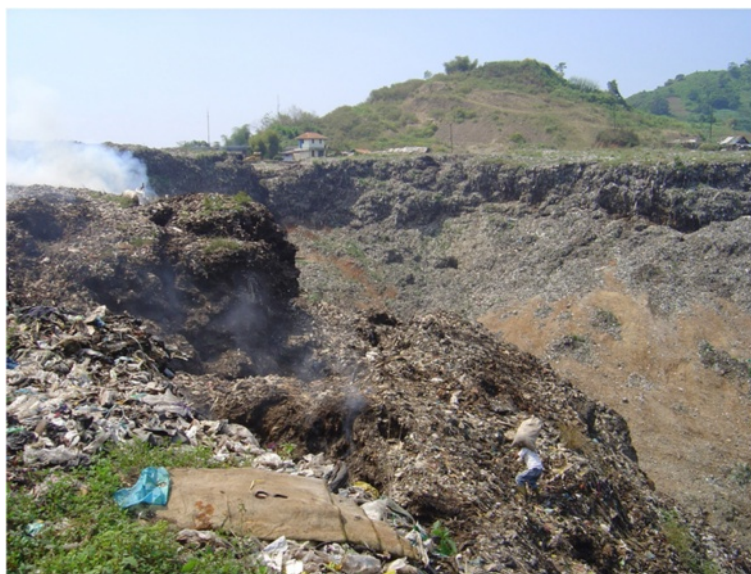
**Figure 4 Scarp of the dumpsite after the February 2005 disaster.** In the foreground, a scavenger carrying reusable material from the dumpsite. In the background, the steep natural slope in brown color (photo: F. Lavigne, July 2005).

Five months after the February 2005 disaster, the upstream part of the dumpsite displays a 10 m-high scarp cutting the waste accumulation (Figure 4). At the base of the scarp, the waste deposits are very thin or absent because they have been washed away during the 2005

event. The Figure 4 clearly shows that the gradient of the natural slope was very high, in the order of 45°.

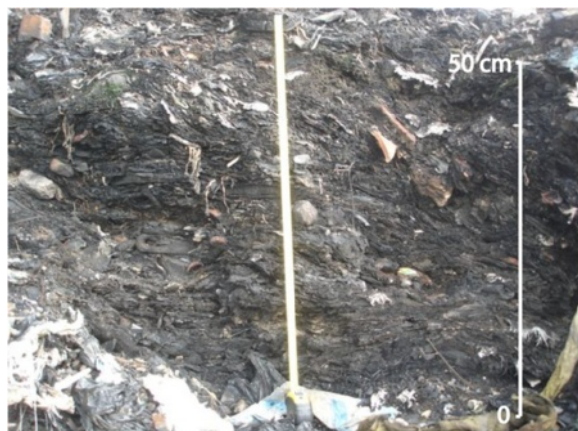
**Figure 6** Internal structure of the deposit showing undulating discontinuities and foliated layers (photo: P. Wassmer, February 2007).

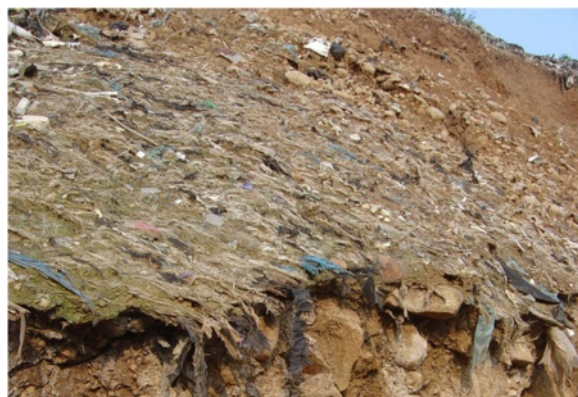
**Figure 7** Pieces of plastic bags displaying horizontal orientations along the post-disaster scarp of the dump (Photo: F. Lavigne, July 2005).
